## Delphi Knowledge Article Series

### FG1978 Fuel Module

### Contamination Issue

- 2014-2019 (DS) RAM 1500 Pickup w 3.0 EcoDiesel Engine

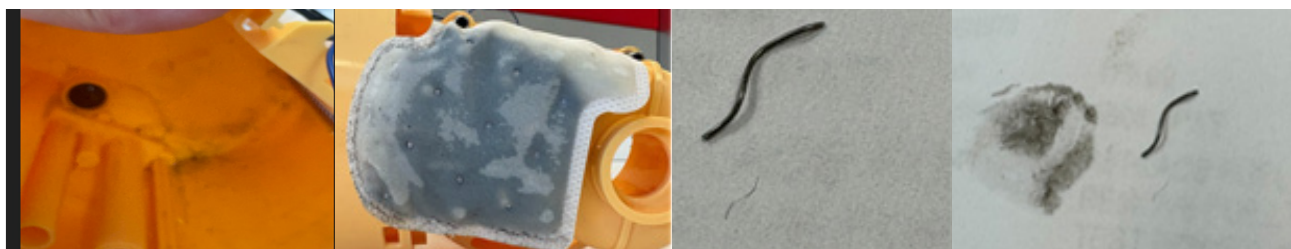
The High-Pressure Fuel Pump (“HPFP”) involving the above vehicle may fail prematurely. As per NHTSA Reference: Z46 / NHTSA 22V-406, **a HPFP failure may introduce internally failed component debris into the fuel system potentially causing fuel starvation.** This debris is contaminating the fuel supply system causing the in-tank fuel module to stop working and supplying fuel to the HPFP. Simply replacing the in-tank fuel module FG1978 will not solve the problem, and the **fuel module will fail prematurely due to the debris contamination.**

These above metal shavings are found in the pump reservoir and filter assembly. Ingestion of metal shavings produced by a failing HPFP is not the fault of the in-tank module FG1978.

**Debris in the fuel system causes the pump to fail.**

Stellantis has released a Safety Recall notice on this matter – Recall 01A, Z46 or Z96 Engine High-Pressure Fuel Pump Repair. It is necessary to replace the HPFP, and inspect and replace, if necessary, additional contaminated fuel system components.
