# WORK SMARTER, NOT HARDER WITH **DELPHI VEHICLE TECHNICAL INFORMATION**

**FAULT CODE: 2A1100**

**BMW X3 2.0i**

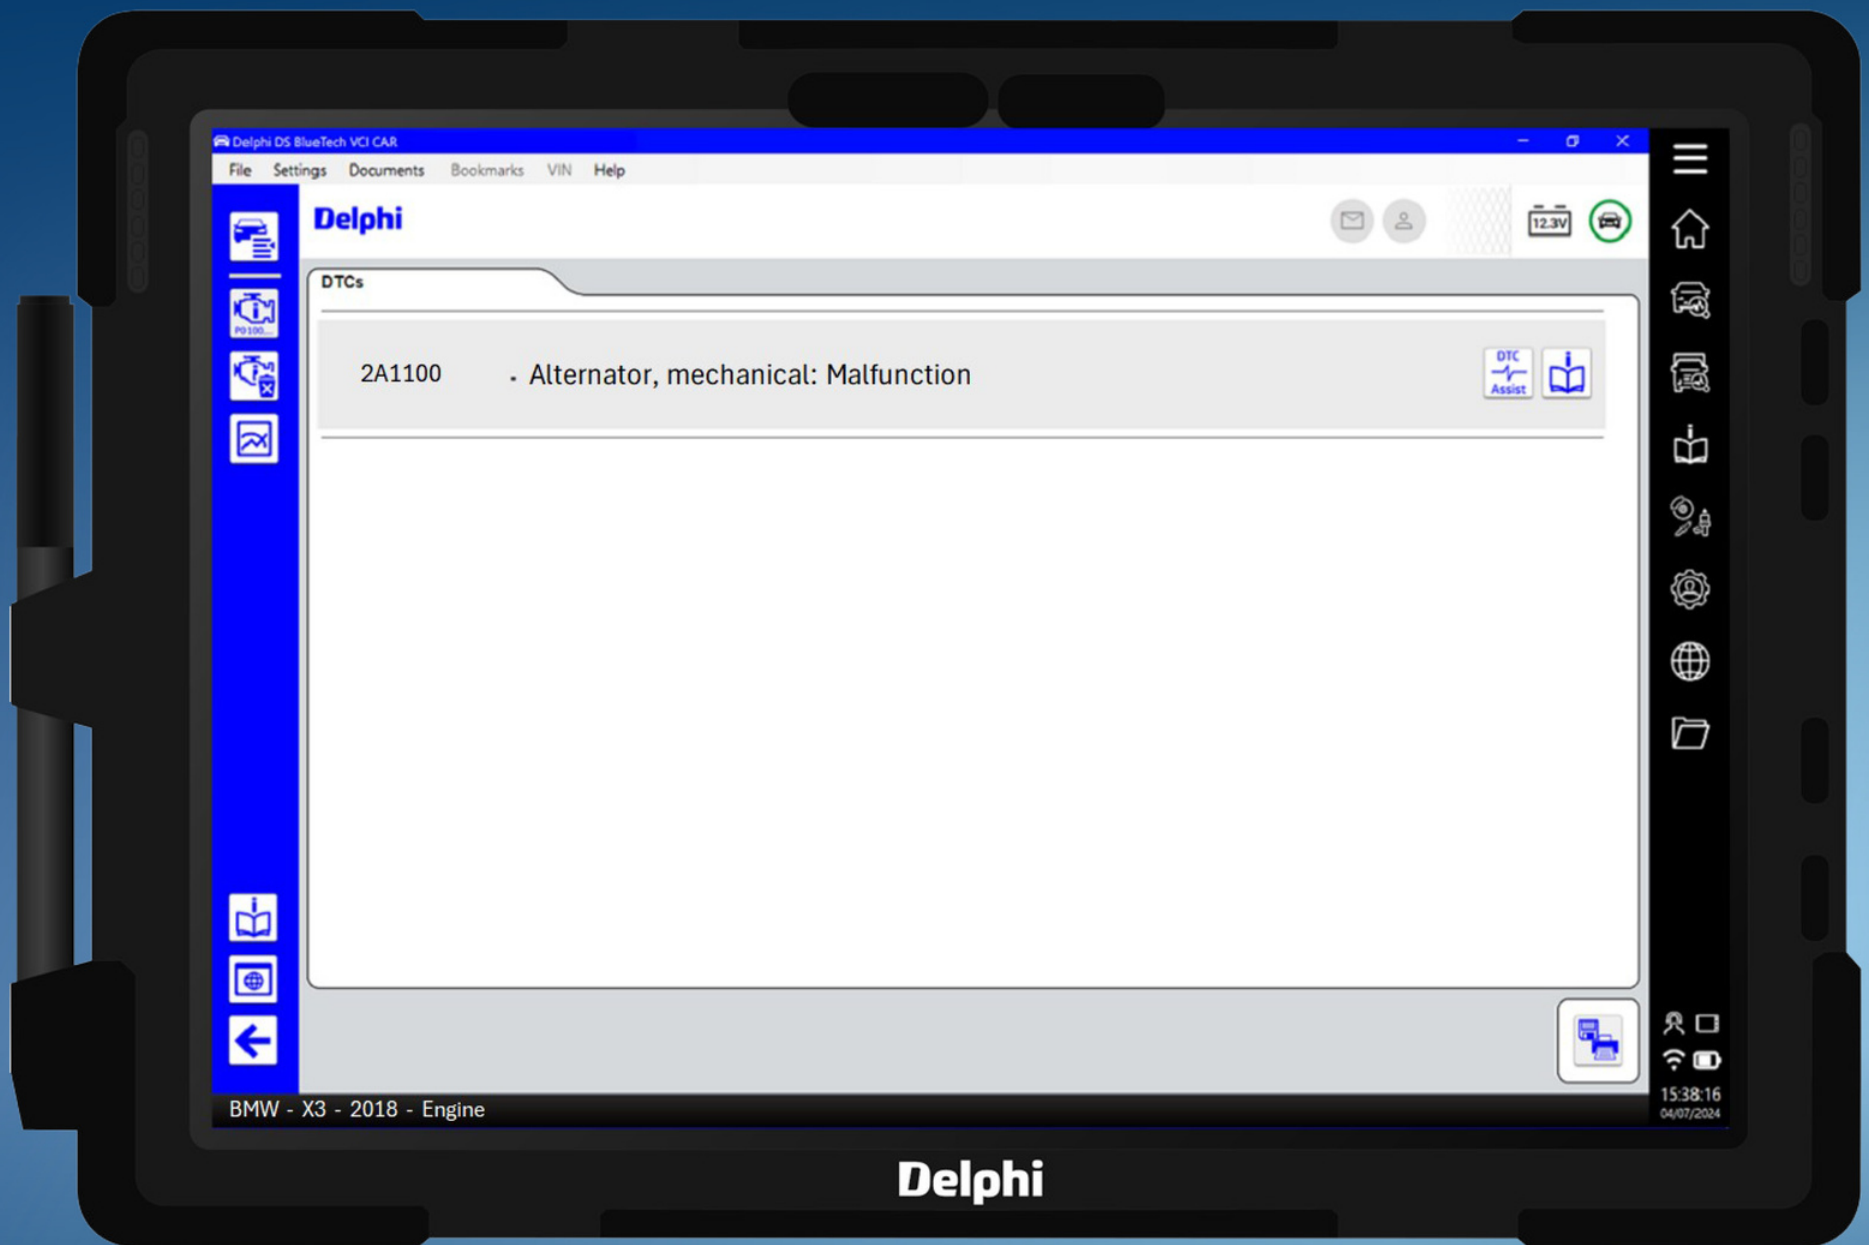
**FAULT CODE: 2A1100**

**Engine warning light,  
engine vibration**

**Faulty vibration damper**

**Check and replace vibration damper -  
if fault code is still present,  
change alternator**
